# Maßnahmenplanung kleine Spree Abschnitt 3 : von km 7,800 bis km 13,200

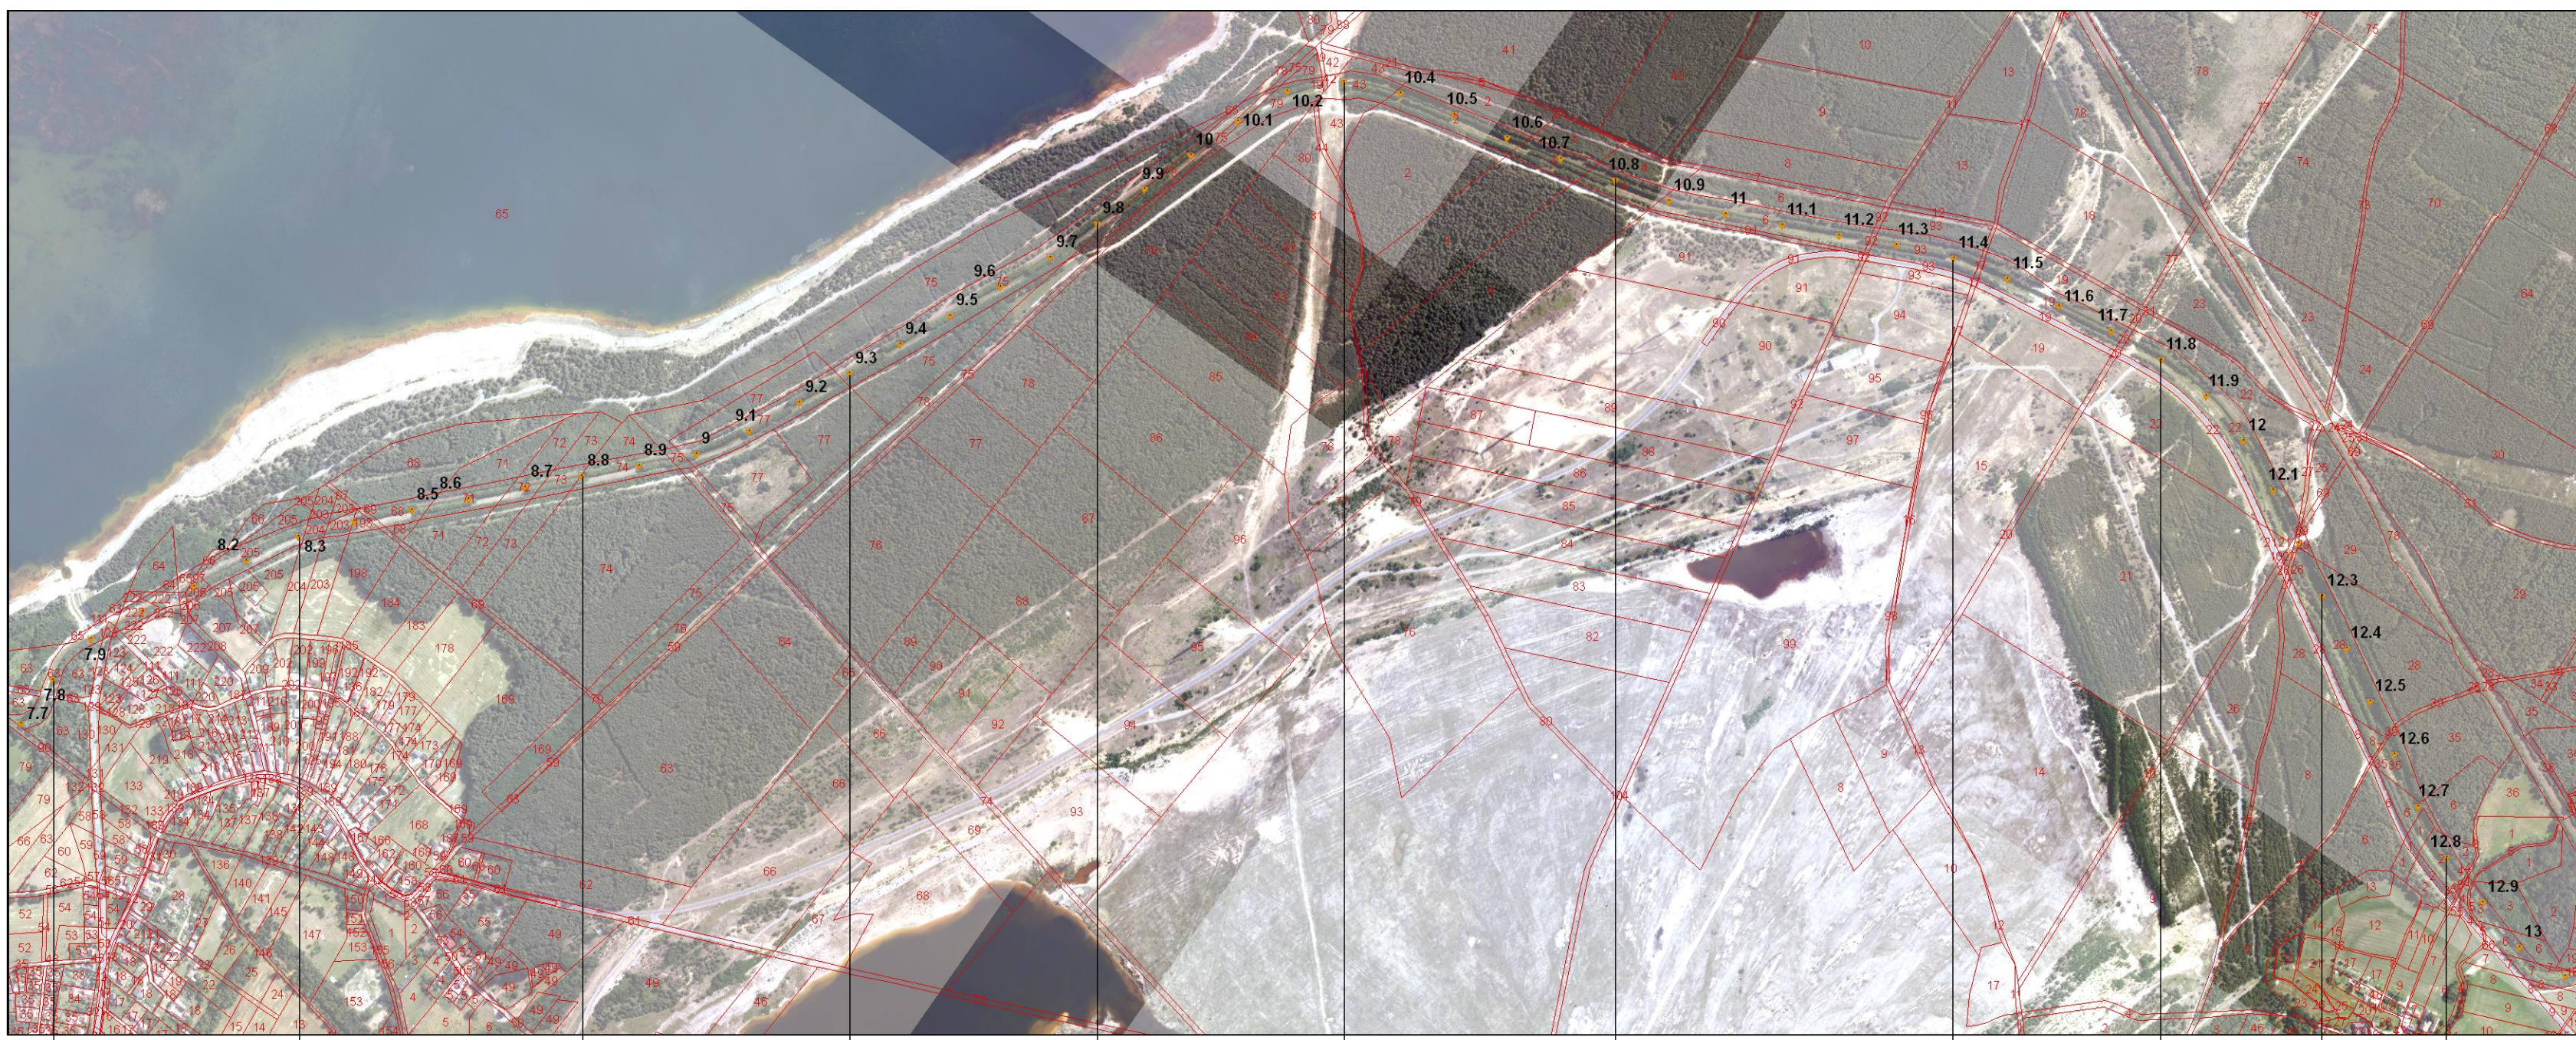
Kilometrierung Strukturkartierung [km] 7,8 8,0 8,5 9,0 9,5 10,0 10,5 11,0 11,5 12,0 12,5 13,0 13,2

Maßnahmen	Strahiquell Burghammer					Trittsstein Scheibe				
	1	2	1	1	2	1	2	2	1	
Trittsstein / Strahiquell										
Bühne	1	2	1	1	2	1	2	2	1	
Raubaum	2	1	1	1	1	1	1	1	1	
Kiesbank / Laichbett			1			1	1		1	
Flachunterland		1		1						
Aufweitung										
Laufgestaltung										
Einengung			1	1		1	1		1	
Wurzelsöcke	1	2	1			2	1	1	2	
Laufgabekung							1			
Anpflanzung	1	1		1	1	1	1	1	1	
Gewässermandstreifen herstellen										
Uferverbau entfernen										
Sohlbauwerk entfernen										
Querbauwerk umbauen										
Querbauwerk abreißen	1

Bestand	Bewertung	Bewertung									
		Bewertung									
Makrozoobenthos	ökologischer Zustand	[Bar chart showing ecological state across sections]									
	chemischer Zustand	[Bar chart showing chemical state across sections]									
	biologischer Zustand	[Bar chart showing biological state across sections]									
	Modul Saprobie	[Bar chart showing Saprobie module across sections]									
	Modul allg. Degradation	[Bar chart showing general degradation module across sections]									
	Fauna-Index	[Bar chart showing Fauna-Index across sections]									
	Litoral-Besiedler %	[Bar chart showing Litoral-Besiedler % across sections]									
	Pelal-Besiedler %	[Bar chart showing Pelal-Besiedler % across sections]									
	EPT-Taxe %	[Bar chart showing EPT-Taxe % across sections]									
	Artenzahl Trichoptera	[Bar chart showing number of Trichoptera species across sections]									
Phys.-Chem. Belastungen	Eisen [3 mg/l]	[Dot plot showing iron levels across sections]

Sulfat [240 mg/l]	[Dot plot showing sulfate levels across sections]									
	Gesamtposphor [0,1 mg/l]	[Dot plot showing total phosphorus levels across sections]									
	NH4-N [0,3 mg/l]	[Dot plot showing ammonium-nitrogen levels across sections]									
	Verbraunung [ab 3 mg/l Eisen]	[Dot plot showing discoloration levels across sections]									
Hydromorphologie	Beschattung	[Bar chart showing shading across sections]									
	Besondere Laufstrukturen	[Bar chart showing special flow structures across sections]									
	Besondere Uferstrukturen	[Bar chart showing special bank structures across sections]									
	Besonderer Sohlstrukturen	[Bar chart showing special bed structures across sections]									
	Störungsdiversität	[Bar chart showing disturbance diversity across sections]									
	Sohlverbau	[Bar chart showing bed construction across sections]									
	Uferverbau	[Bar chart showing bank construction across sections]

Tiefenverlärz	[Bar chart showing depth diversification across sections]										
Querbauwerk	[Bar chart showing cross-structures across sections]
